## CASE REPORT

# Coronary and Right Ventricular Perforations: Frying pan and the Fire.

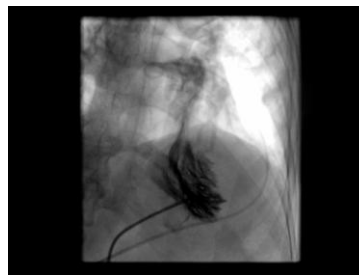
**Figure 4: RV Gram**

Another femoral sheath was inserted into the pericardial space via the subxiphoid window, and this time the pressure transducer did not reveal RV pressure tracings. Fresh blood was drained and transfused via the femoral vein. A five French pigtail catheter was introduced into the pericardial cavity and left in place using a catheter-over-wire technique for further drainage and autotransfusion via the femoral vein. After the patient's blood pressure improved, a repeat angiogram demonstrated successful sealing of the perforation and TIMI III flow from the LMS to the distal LAD. Collaboration with a structural heart cardiologist and cardiac surgeon was sought. Despite mild residual pericardial effusion still observed on repeated TTE, and persistent blood tapping from the pericardial space, a right ventricular angiogram was performed via transthoracic access to confirm the location of the sheath within the RV cavity. A second RV angiogram, accessed through the femoral vein, revealed dye leakage into the pericardial space (Figure 4).

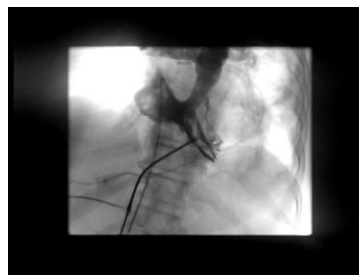
**Figure 5: PDA device implanted to close RV perforation.**

**Figure 6: PDA device implanted to close RV perforation**

The transthoracic sheath was upgraded from 6F to 7F femoral sheath, and a Cera TM 6x8 Patent Ductus Arteriosus (PDA) occluder device (LifeTech Scientific) was placed in the RV wall (Figure 5 & 6). Another RV angiogram demonstrated an additional site of oozing at the RV apex (Figure 7).
